**AFFDL-TR-78-175**  
**Volume III**

**EFFECT OF MULTIAXIAL LOADING  
ON CRACK GROWTH  
Volume III - Compilation of Interferometry Photographs**

*NORTHROP CORPORATION  
AIRCRAFT GROUP  
HAWTHORNE, CALIFORNIA 90250*

*December 1978*

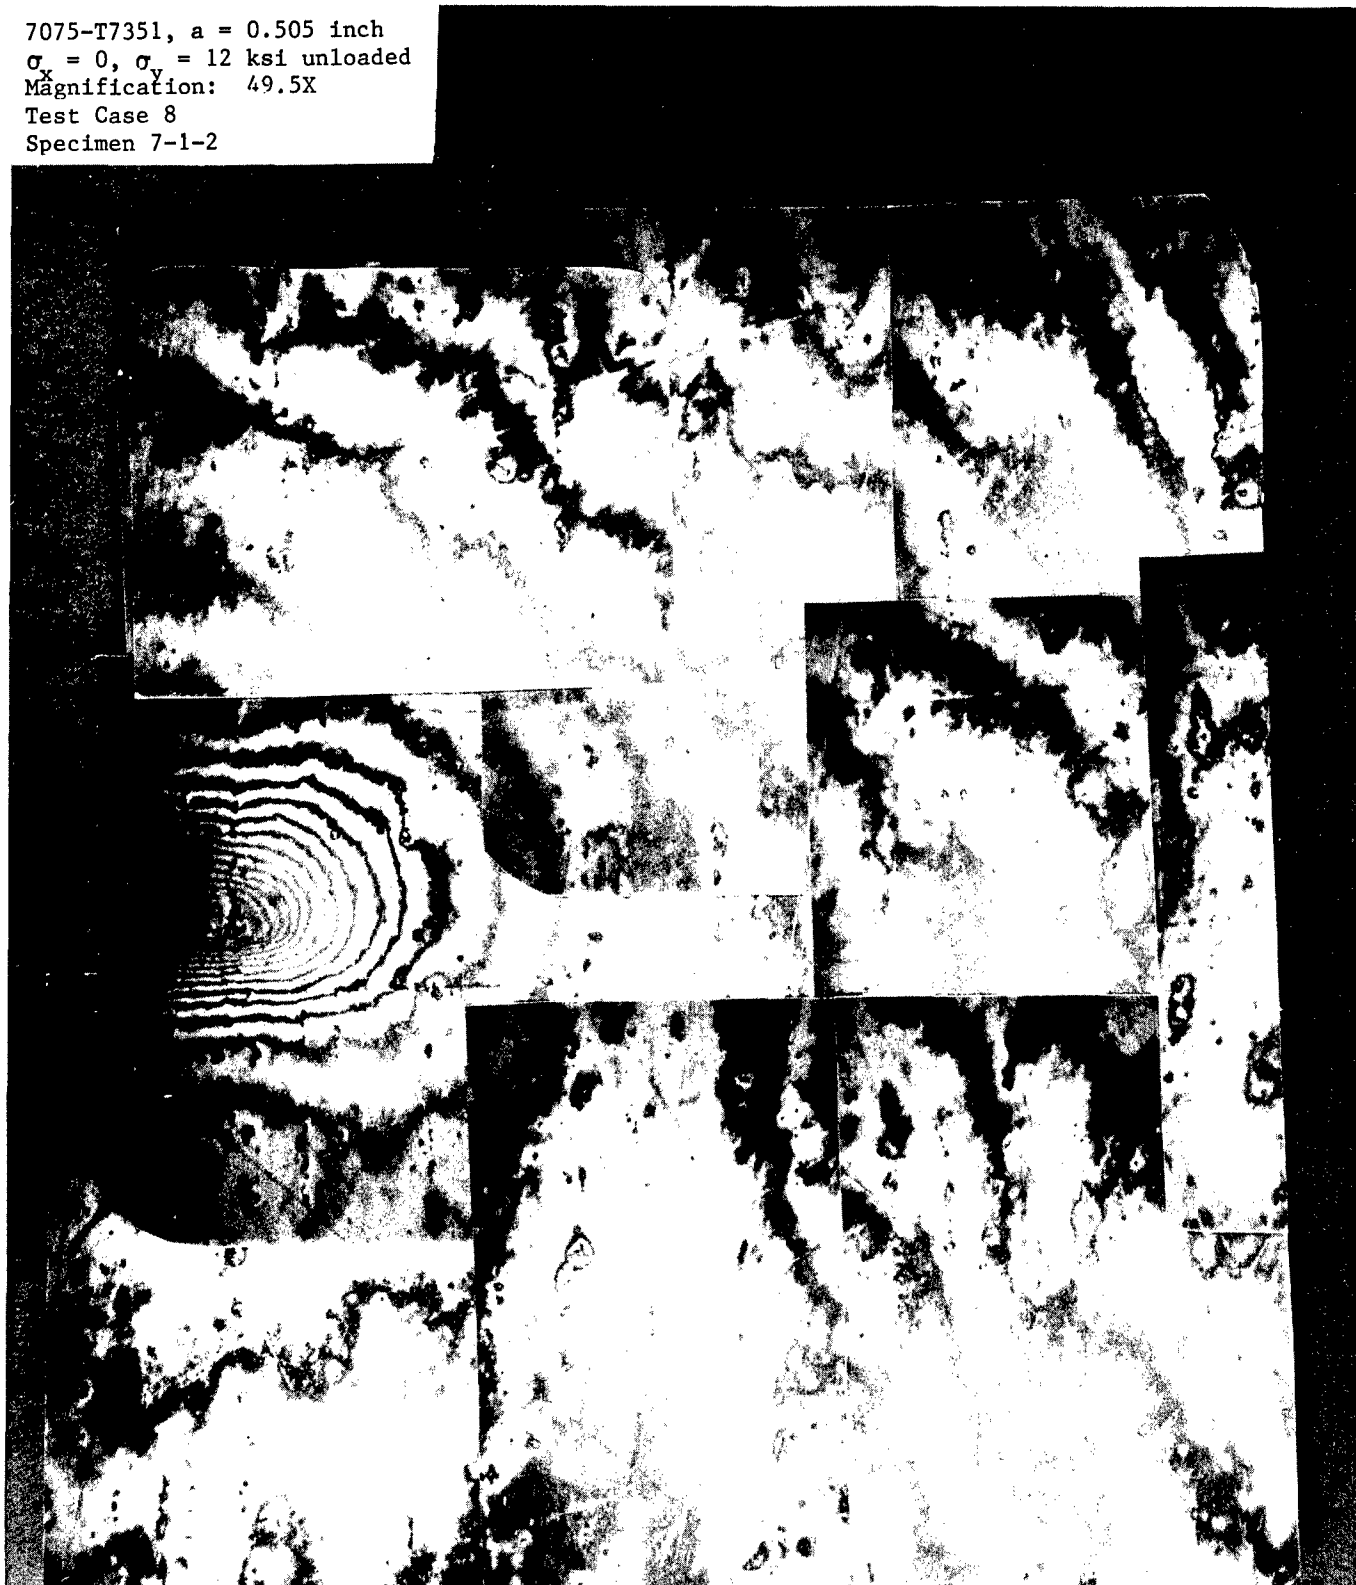
Figure 1. Interferometry Photograph of an Unloaded Crack in a 7075-T7351 Specimen

7075-T7351,  $a = 0.505$  inch  
 $\sigma_x = 0$ ,  $\sigma_y = 12$  ksi unloaded  
Magnification: 49.5X  
Test Case 8  
Specimen 7-1-2

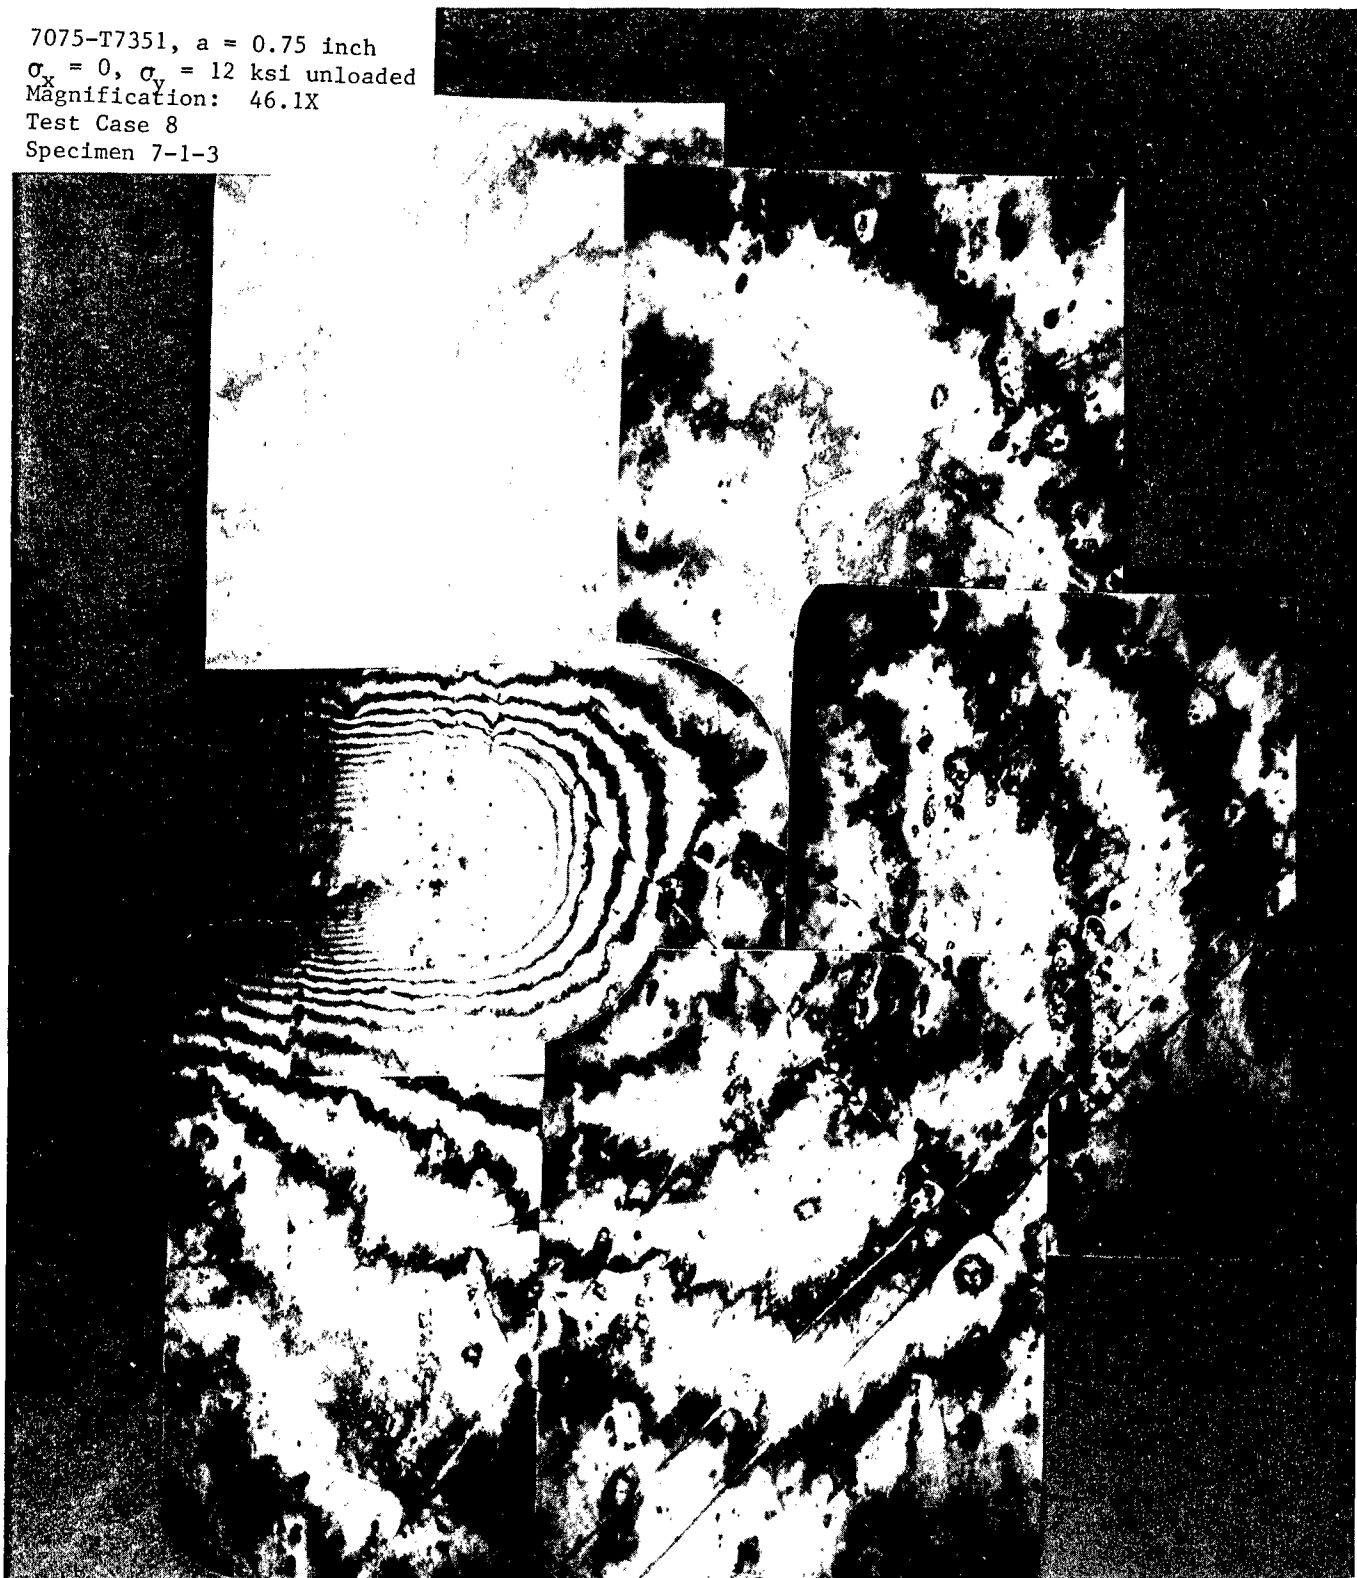
Figure 2. Interferometry Photograph of an Unloaded Crack in a 7075-T7351 Specimen

7075-T7351,  $a = 0.75$  inch  
 $\sigma_x = 0$ ,  $\sigma_y = 12$  ksi unloaded  
Magnification: 46.1X  
Test Case 8  
Specimen 7-1-3

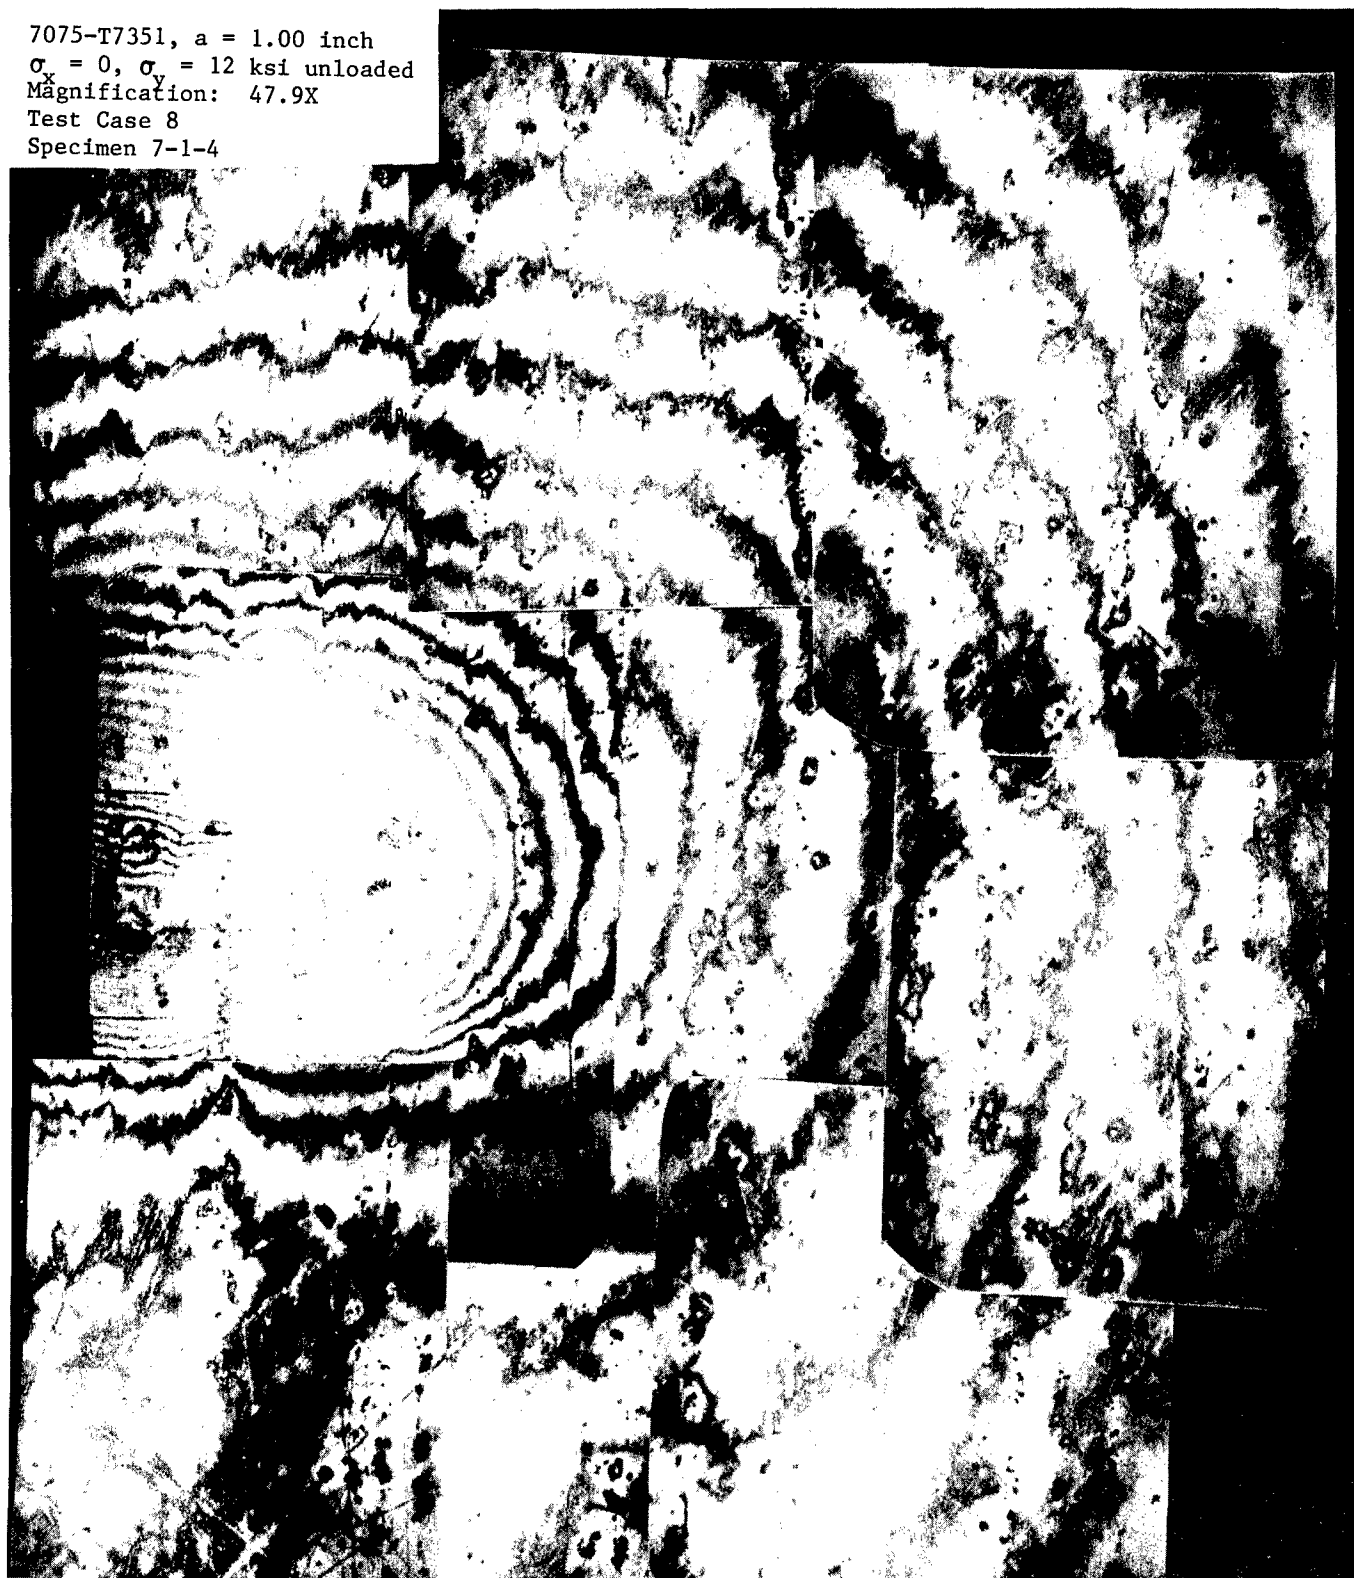
Figure 3. Interferometry Photograph of an Unloaded Crack in a 7075-T7351 Specimen

7075-T7351,  $a = 1.00$  inch  
 $\sigma_x = 0$ ,  $\sigma_y = 12$  ksi unloaded  
Magnification: 47.9X  
Test Case 8  
Specimen 7-1-4

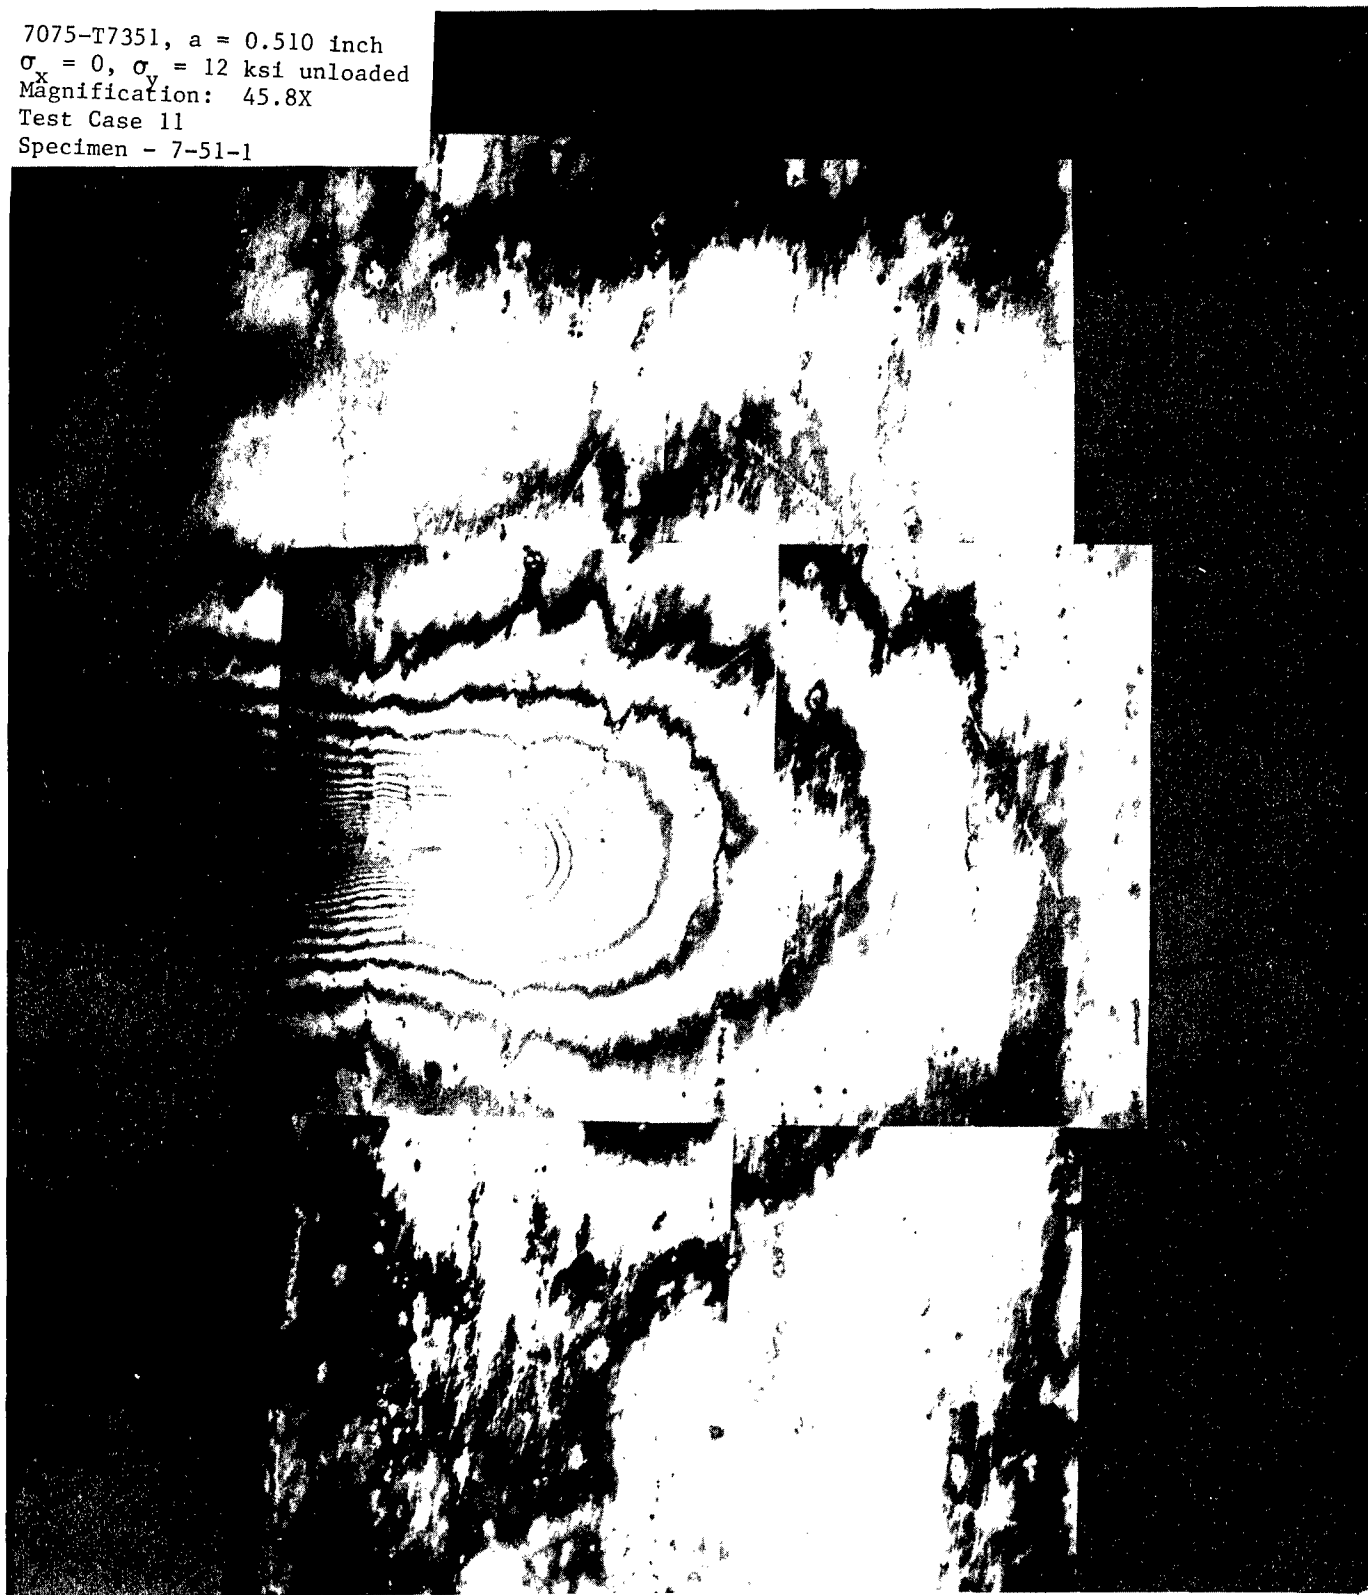
Figure 4. Interferometry Photograph of an Unloaded Crack in a 7075-T7351 Specimen

7075-T7351,  $a = 0.510$  inch  
 $\sigma_x = 0$ ,  $\sigma_y = 12$  ksi unloaded  
Magnification: 45.8X  
Test Case 11  
Specimen - 7-51-1

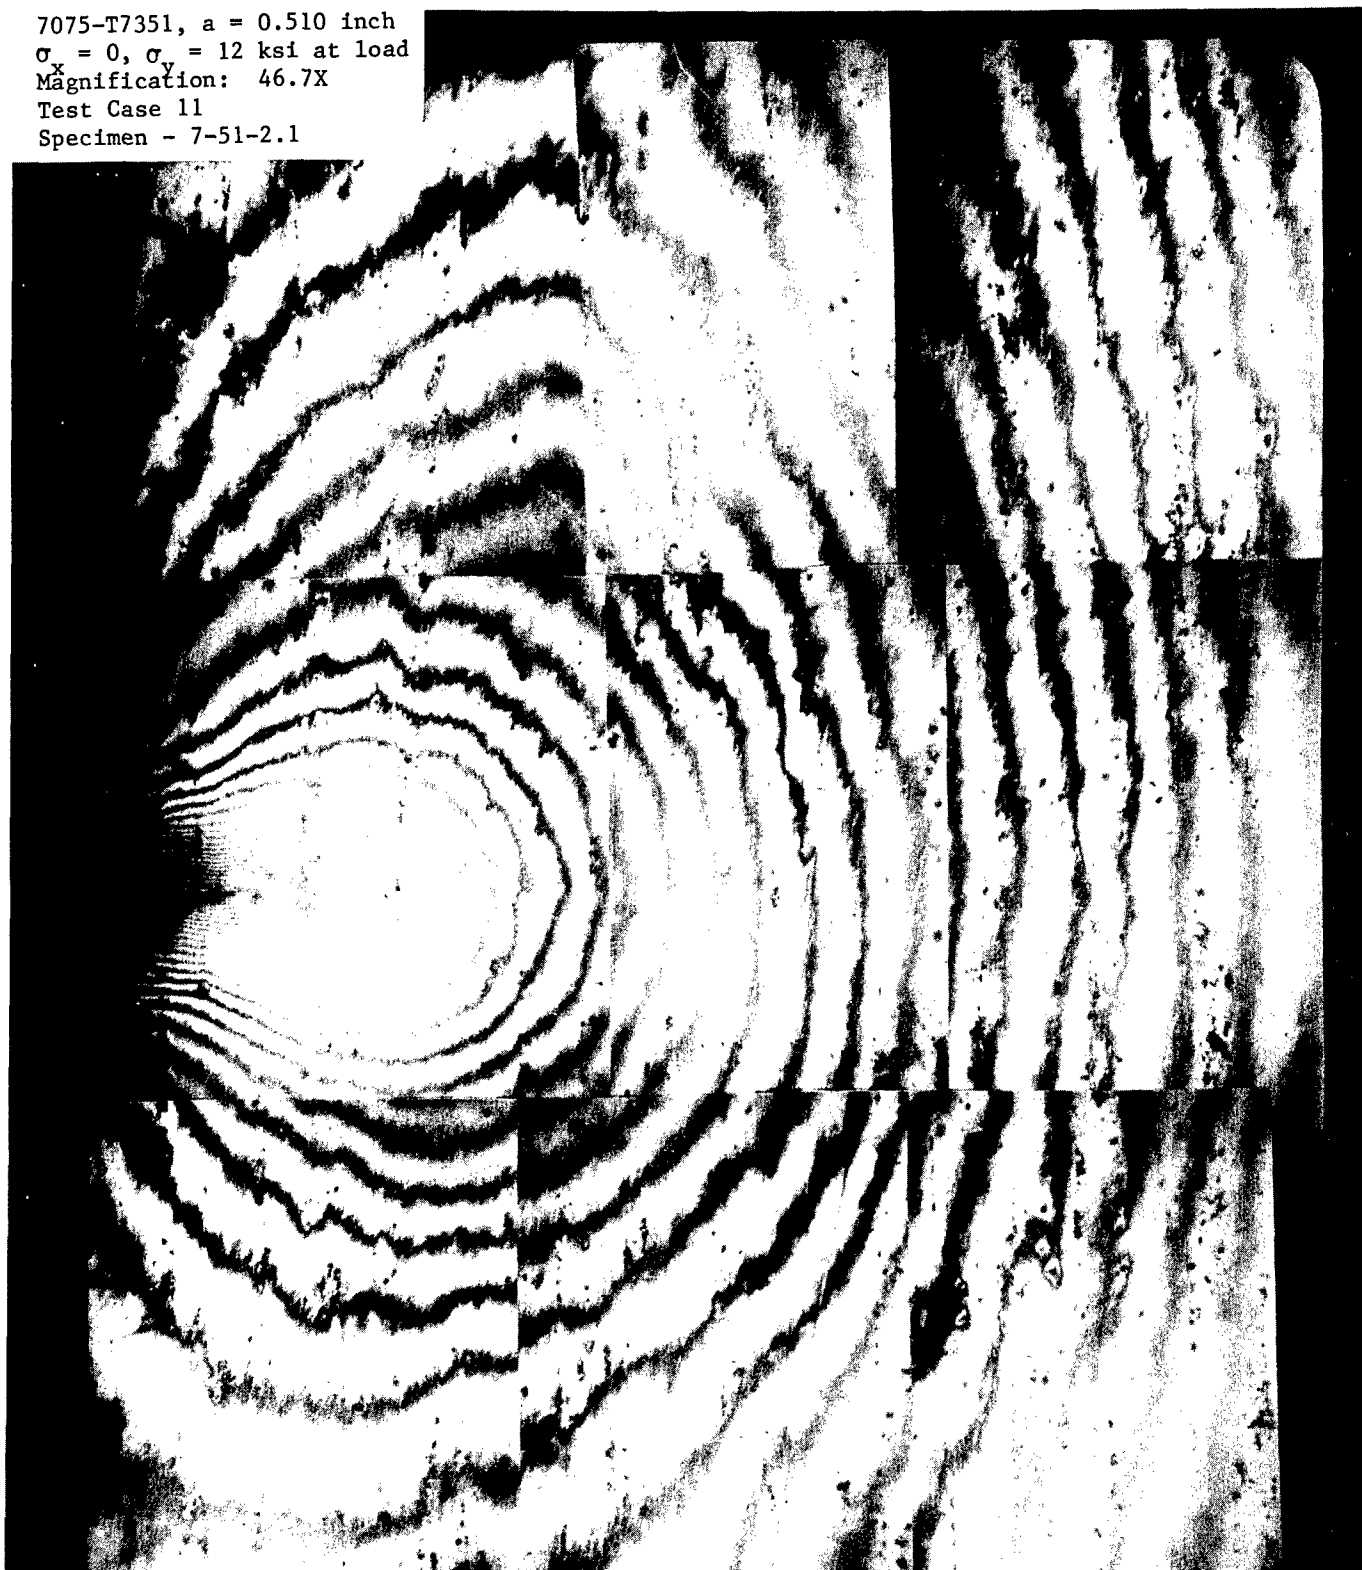
Figure 5. Interferometry Photograph of an Unloaded Crack in a 7075-T7351 Specimen

7075-T7351,  $a = 0.510$  inch  
 $\sigma_x = 0$ ,  $\sigma_y = 12$  ksi at load  
Magnification: 46.7X  
Test Case 11  
Specimen - 7-51-2.1

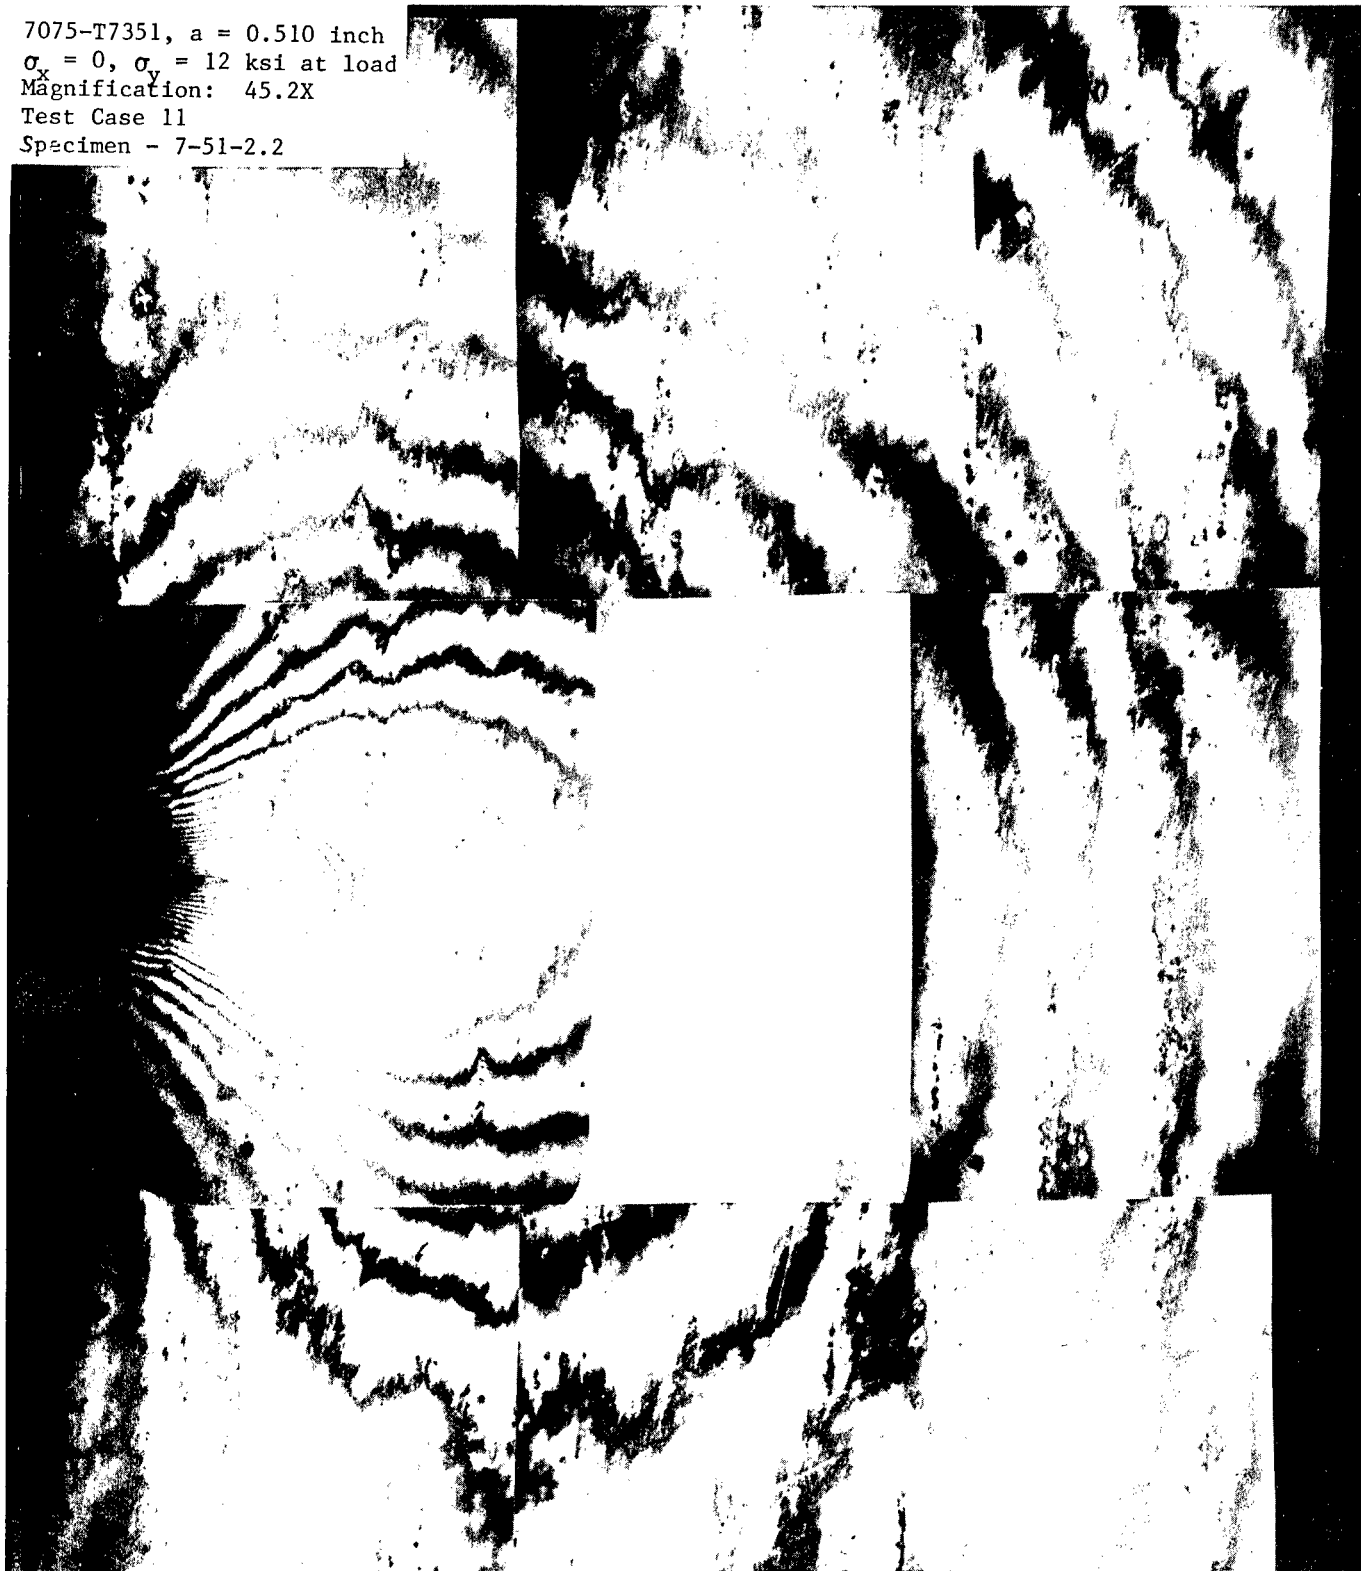
Figure 6. Interferometry Photograph of a Loaded Crack in a 7075-T7351 Specimen

7075-T7351,  $a = 0.510$  inch  
 $\sigma_x = 0$ ,  $\sigma_y = 12$  ksi at load  
Magnification: 45.2X  
Test Case 11  
Specimen - 7-51-2.2

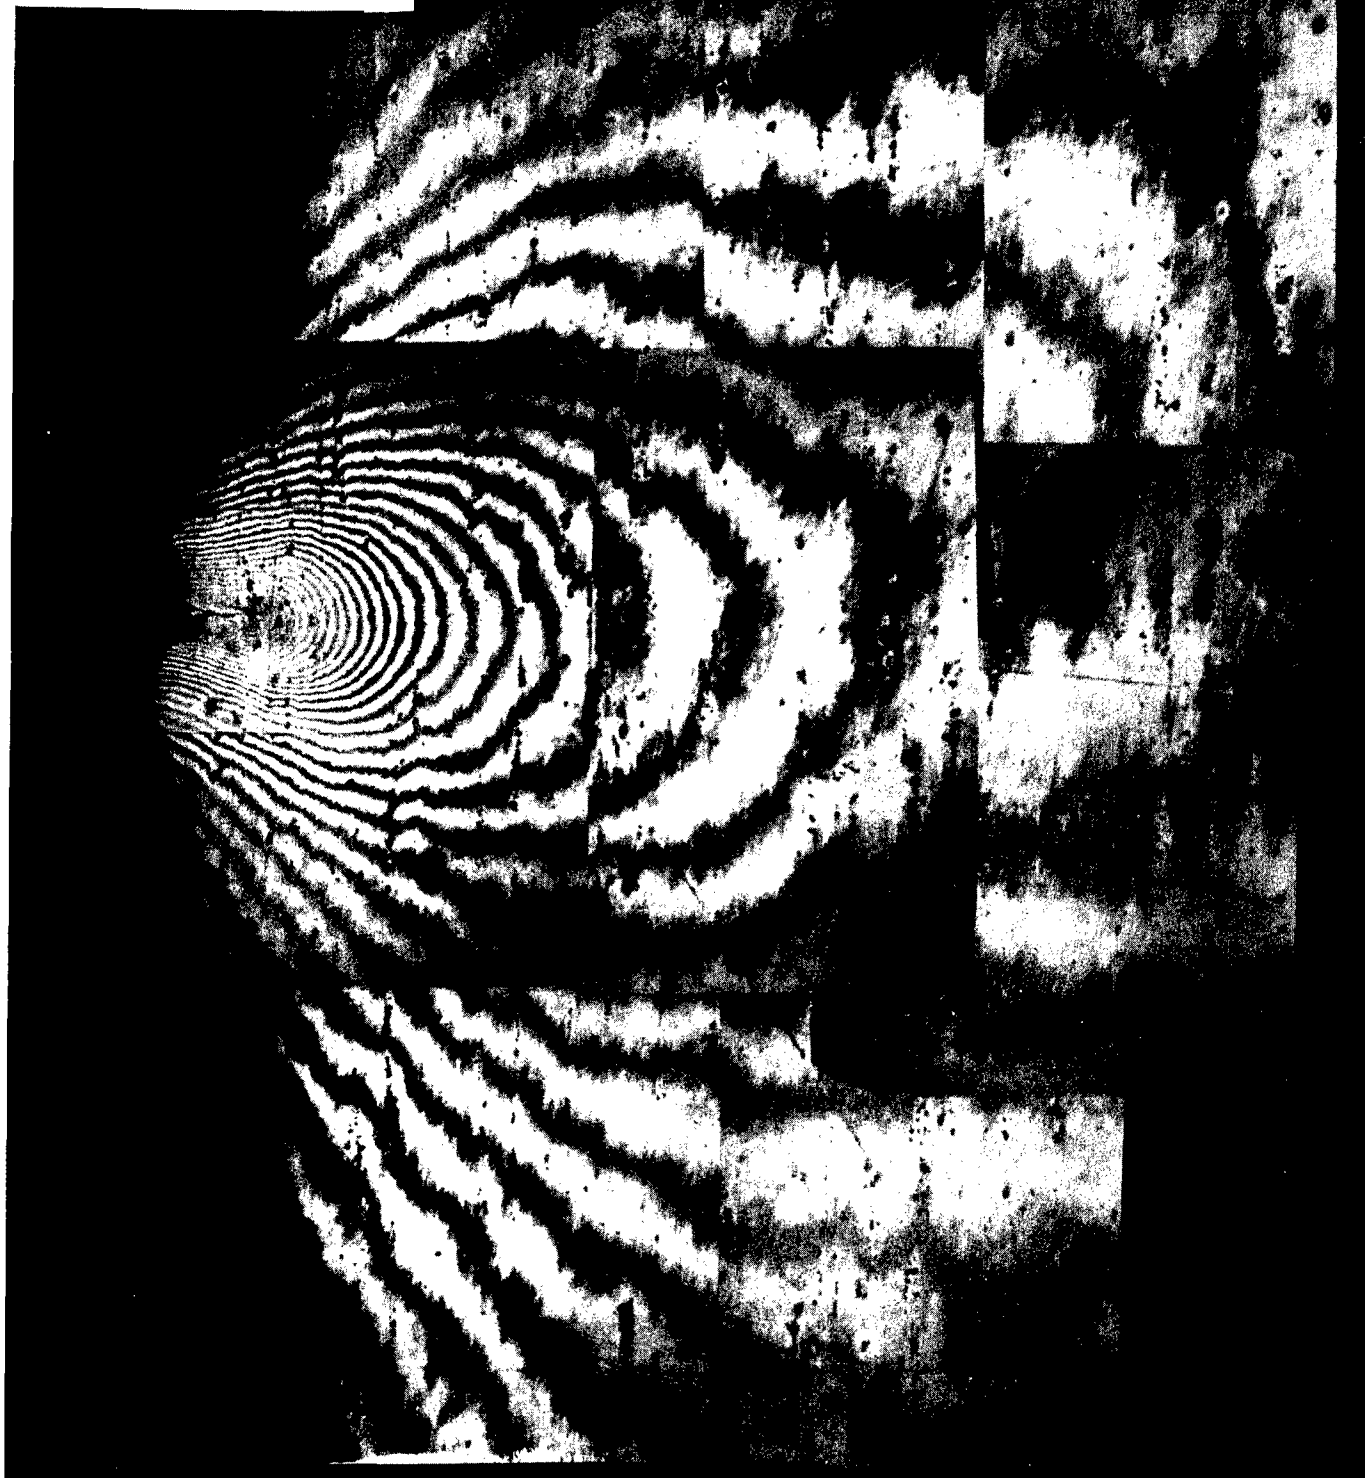
Figure 9. Interferometry Photograph of a Loaded Crack in a 7075-T7351 Specimen

7075-T7351,  $a = 0.760$  inch  
 $\sigma_x = 0$ ,  $\sigma_y = 12$  ksi at load  
Magnification: 45.1X  
Test Case 11  
Specimen - 7-51-4

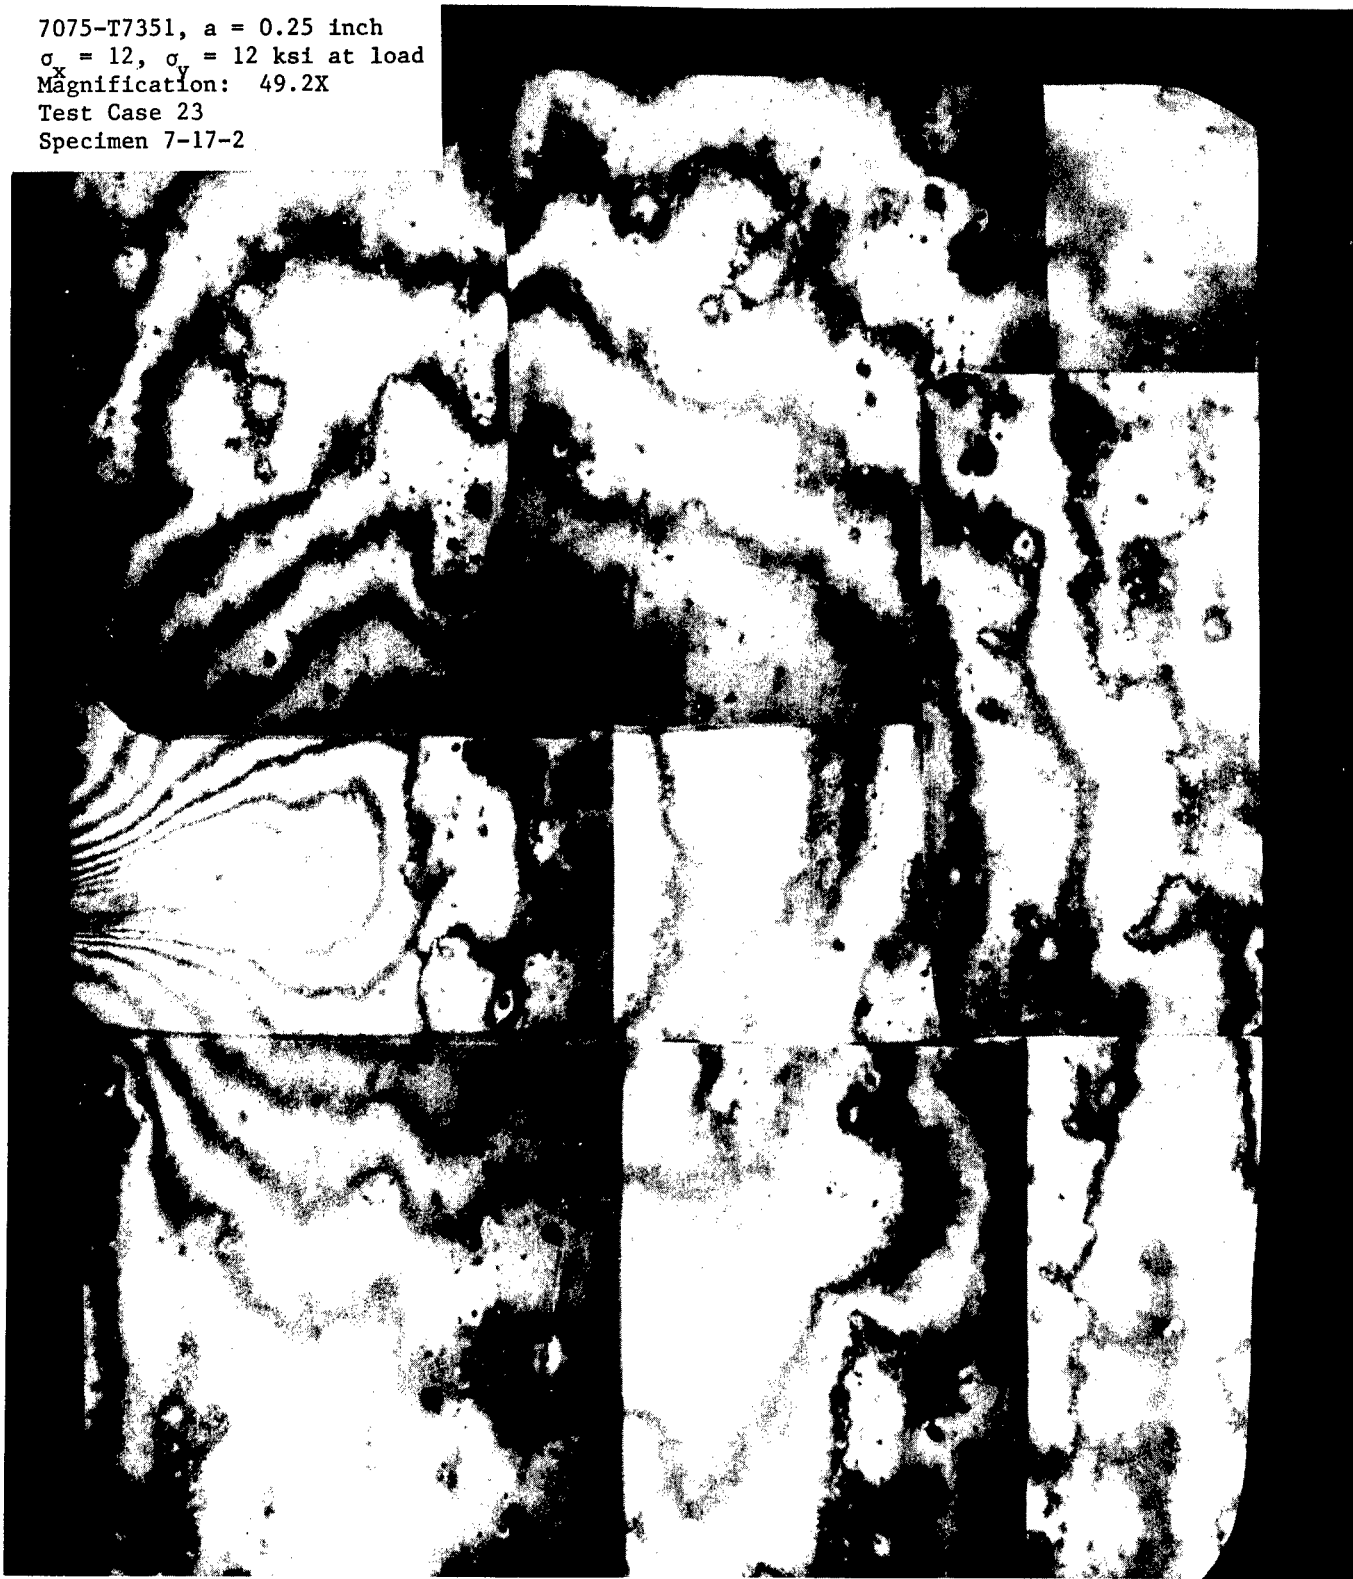
Figure 13. Interferometry Photograph of an Unloaded Crack in a 7075-T7351 Specimen

7075-T7351,  $a = 0.25$  inch  
 $\sigma_x = 12$ ,  $\sigma_y = 12$  ksi at load  
Magnification: 49.2X  
Test Case 23  
Specimen 7-17-2

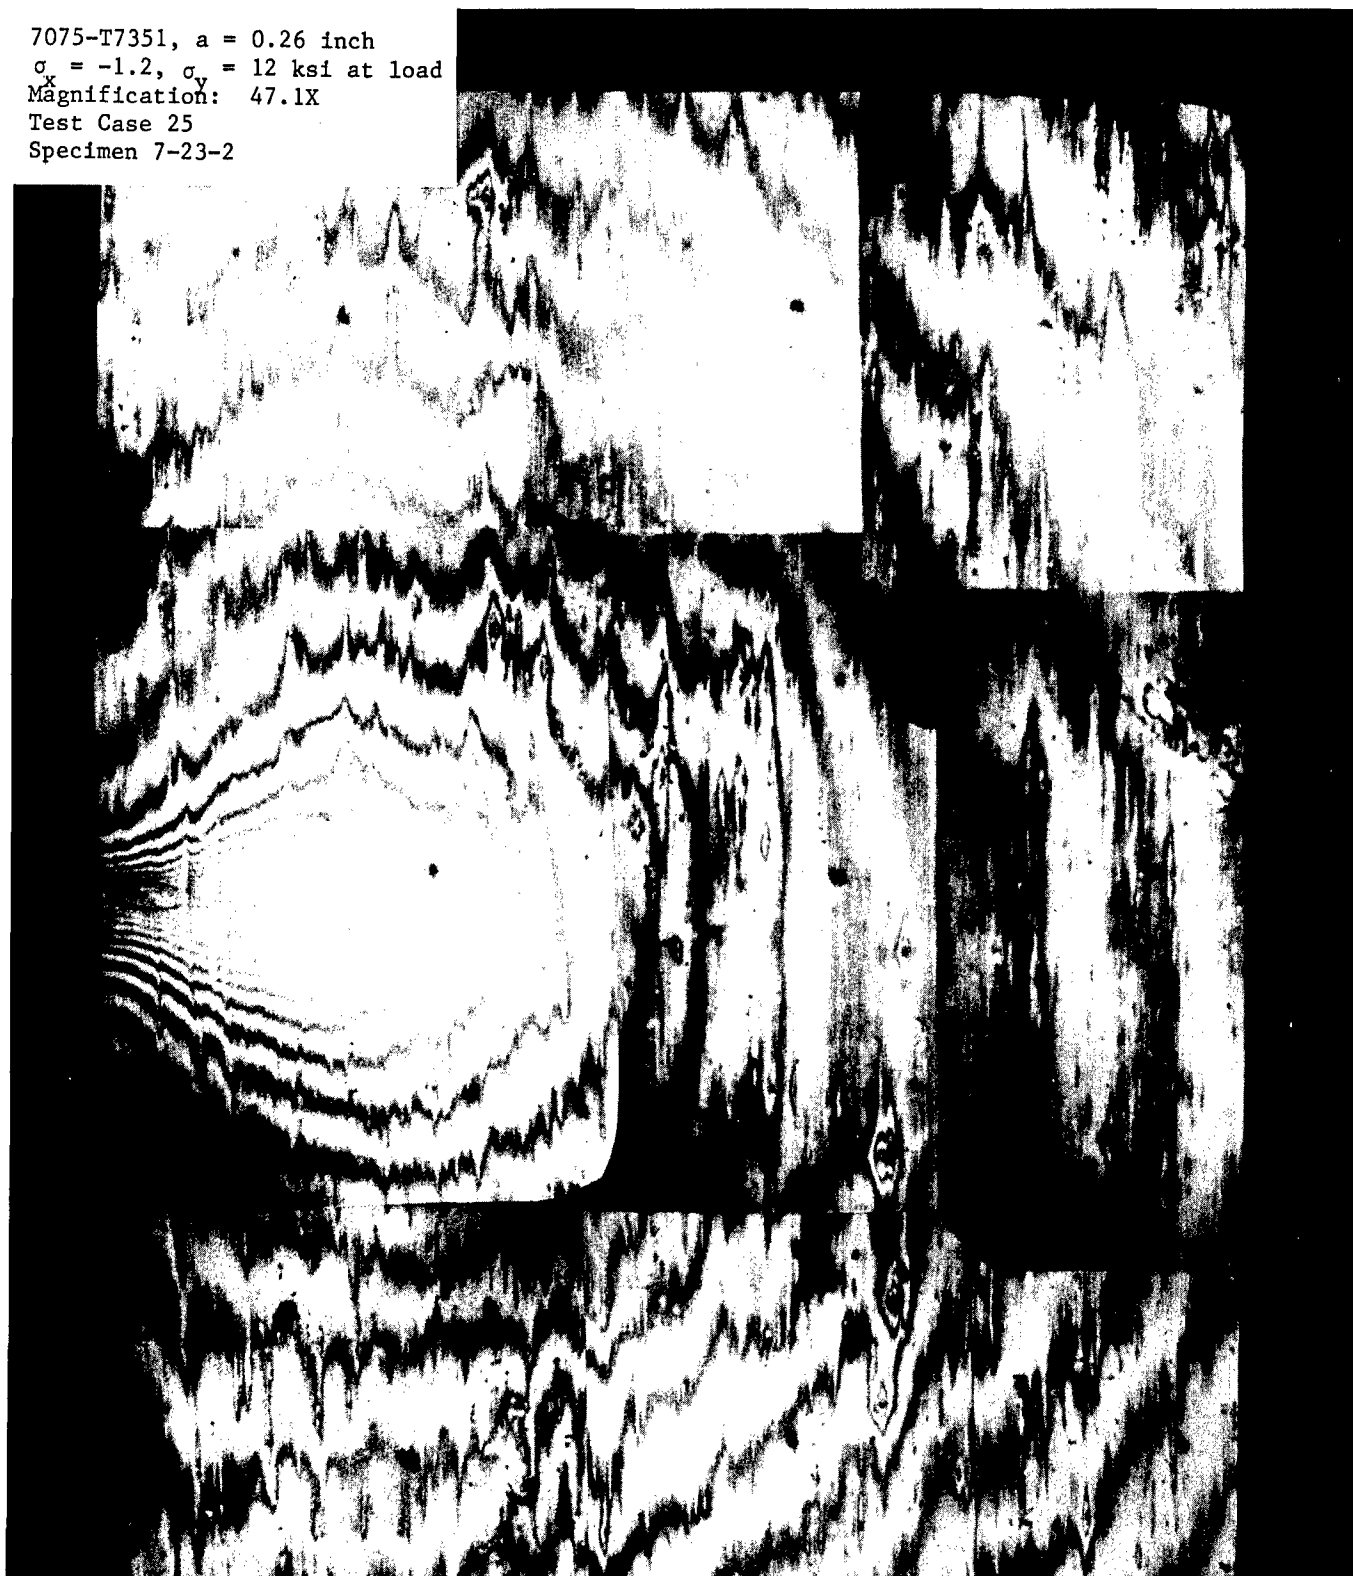
Figure 20. Interferometry Photograph of a Loaded Crack in a 7075-T7351 Specimen

7075-T7351,  $a = 0.26$  inch  
 $\sigma_x = -1.2$ ,  $\sigma_y = 12$  ksi at load  
Magnification: 47.1X  
Test Case 25  
Specimen 7-23-2

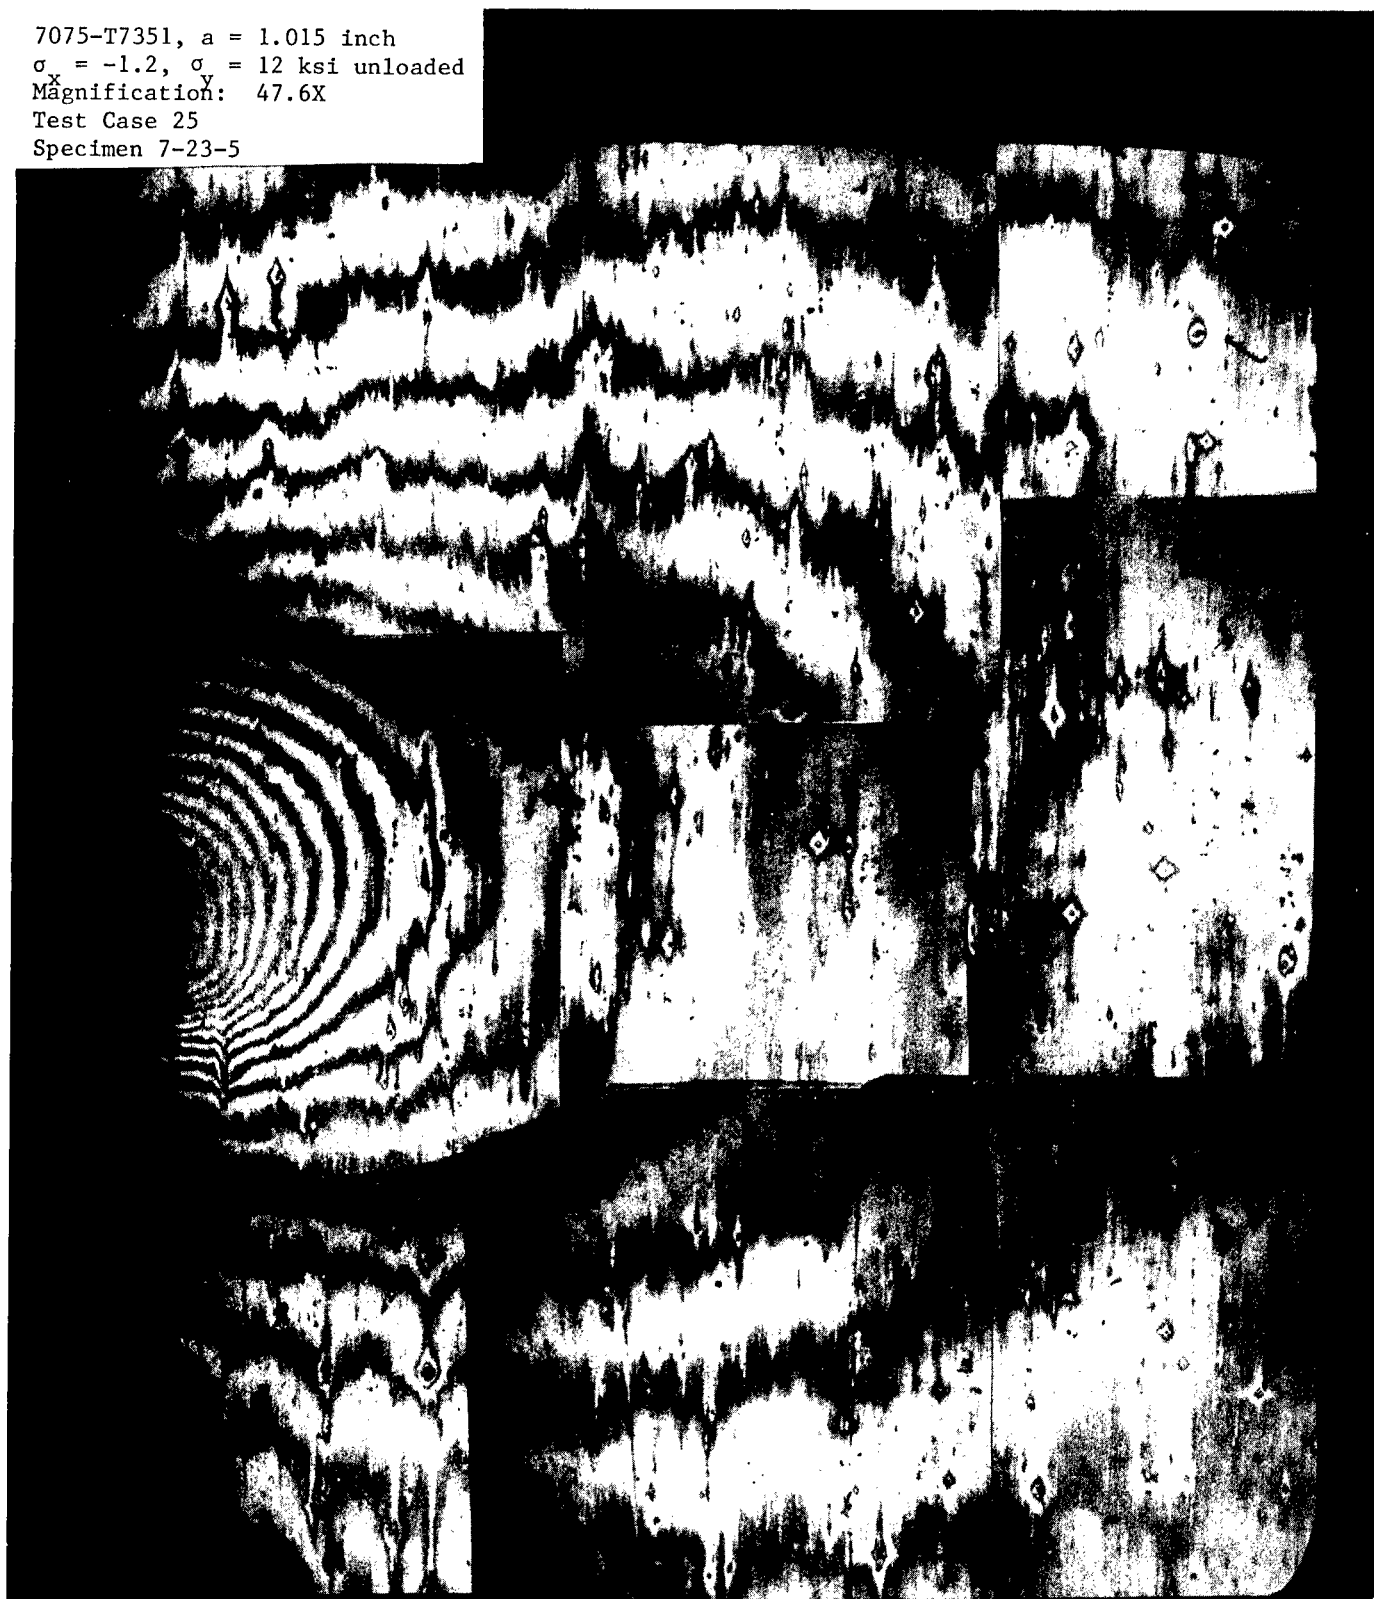
Figure 23. Interferometry Photograph of an Unloaded Crack in a 7075-T7351 Specimen

7075-T7351,  $a = 1.015$  inch  
 $\sigma_x = -1.2$ ,  $\sigma_y = 12$  ksi unloaded  
Magnification: 47.6X  
Test Case 25  
Specimen 7-23-5
